UNITED STATES AIR FORCE IERA

Preliminary Health Risk Assessment, Vladivostok Humanitarian Assistance Ecology Project

August 2000

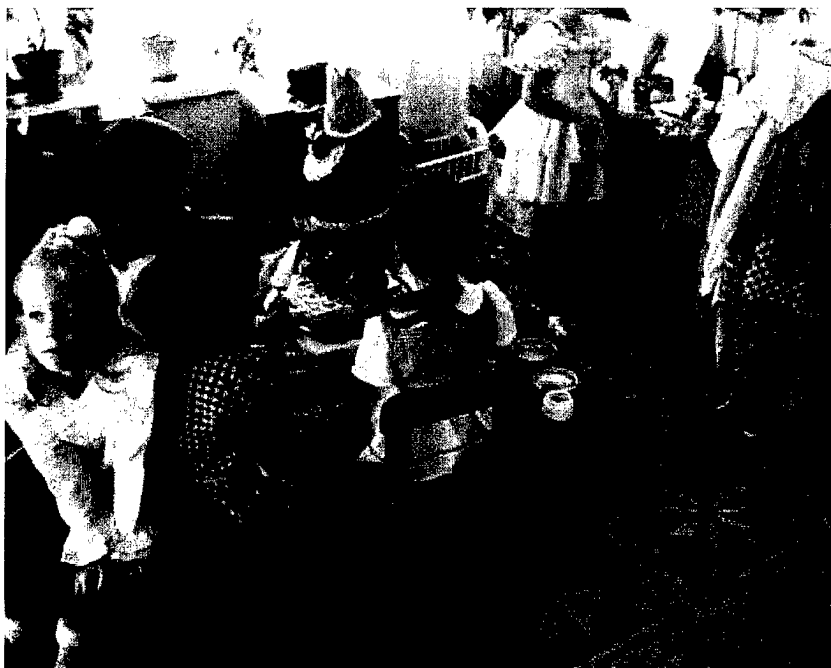
Figure 3. Orange Table at School 141.

Figure 3 shows a table (sample V99C552) located in the 5-year old playroom where the paint tested positive for lead at a level of 4.2 mg/cm^2 .

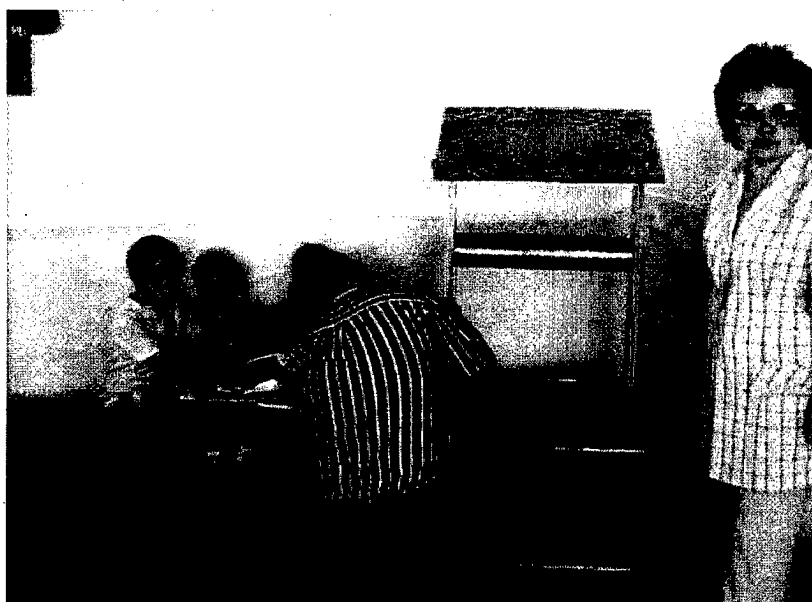
Figure 4. Yellow Bench at School 141.

Figure 4 shows a bench also located in the 5-year old playroom. The bench (sample V99C5528) exhibited a lead concentration exceeding 5 mg/cm^2 . Although the Niton XRF reading indicated that the lead was present below the surface, only the yellow color could be seen.

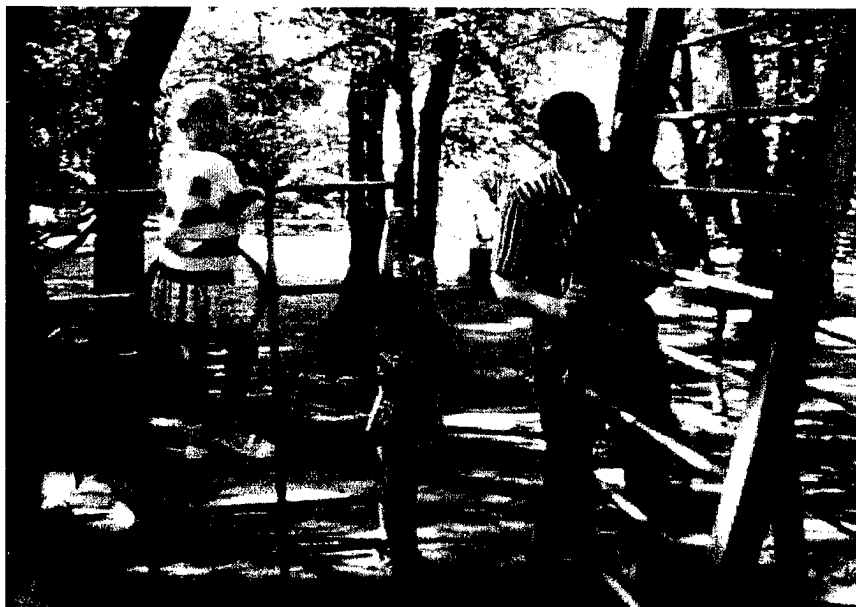
Figure 5. Multicolored Playground Ladder at School 141.

Figure 5 shows a multicolored playground ladder at School 141. The yellow painted surface (sample V99C5505) tested positive for lead at a level of 4.1 mg/cm^2 . The Niton XRF suggested the lead was present 2 layers deep but only the yellow paint was observed in the worn areas.

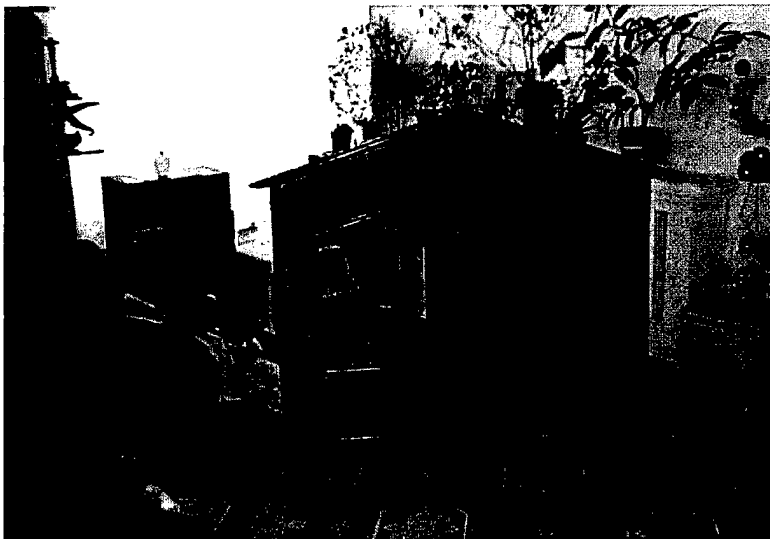
Figure 7. Yellow Playhouse at School 109

Figure 7 shows a yellow playhouse at School 109. The yellow paint on the toy house (sample V99C5316) had a lead concentration of 1.3 mg/cm^2 . The house was located in the 5-6 year old playroom. In the same room there were yellow shelves (sample V99C5317) that showed a lead concentration exceeding 5 mg/cm^2 .

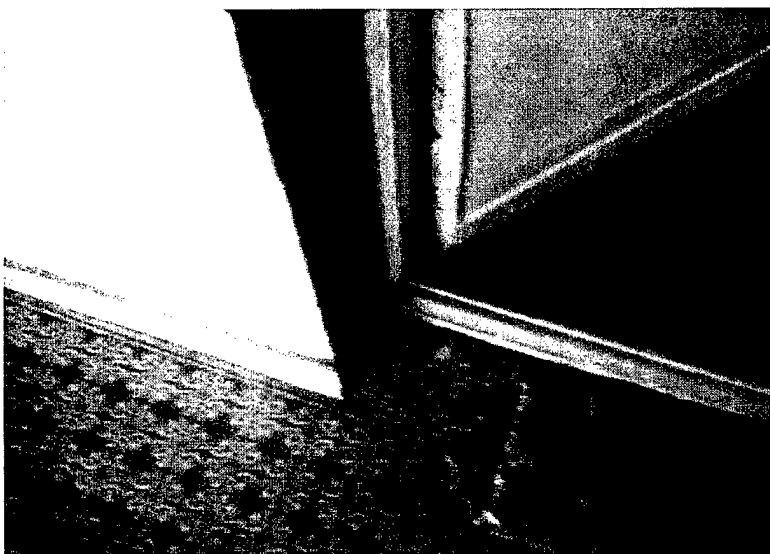
Figure 8. Tan Door Jam at School

Figure 8 shows a tan door jam at School 113. The tan paint on the door jam (sample V99C5004) exhibited a lead concentration of 1.2 mg/cm^2 . The Niton XRF indicated that the lead was located below the surface but no other color of paint could be identified. The door jam was freshly painted. Door jams are of special interest because of the wear the paint receives by opening and closing doors and people walking across them. Over time the paint will wear creating a fine dust. If lead is present it can then be easily transported.

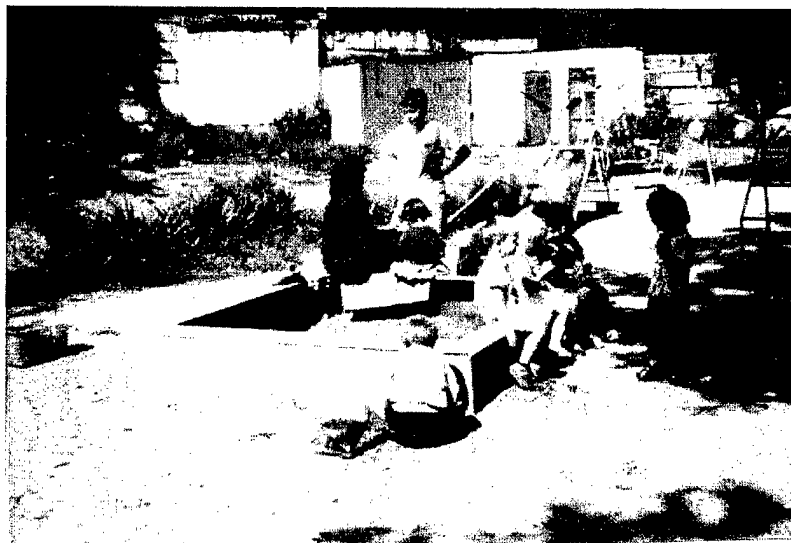
Figure 9. Sandbox at School 132.

Figure 9 shows a sandbox at School 132. The yellow sandbox (sample V99C5251) tested positive for lead with a concentration of 4.1 mg/cm^2 . As can be seen the box is used often and children come in direct contact with the lead containing paint. A soil sample (V99S2041) from a sandbox located at School 132 exhibited a lead concentration of 68 mg/kg . Also of note are the toy giraffes located in the background of the photo. See Figure 10 for a close-up.

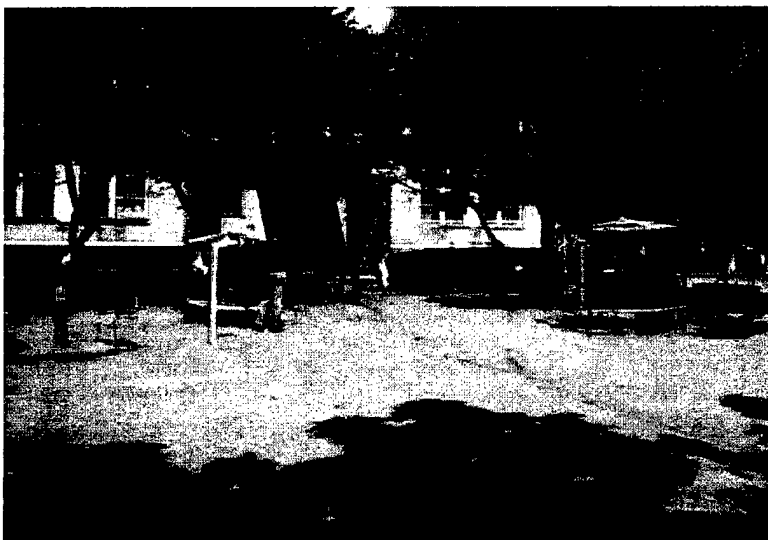
Figure 11. Multicolored Merry-go Rounds at School 162

Figure 11 shows a multicolored merry-go round at School 162. The green and yellow paints (samples V99C5373 and V99C5374, respectively) contained significant levels of lead (greater than 5 mg/cm^2). It was difficult to tell if the green paint was actually the source of lead as the Niton XRF reading indicated the lead was located 2 layers deep and yellow paint was observed below the green. The equipment was worn and much of the paint had deteriorated. Also note the freshly painted yellow pole to the left of the person in the photo. This paint (sample V99C5364) was found to contain lead at a concentration of 2.0 mg/cm^2 .
